Transport  
Canada

# Feedback

Canadian Aviation Service Difficulty Reports

TP 6980E  
(1/2014)

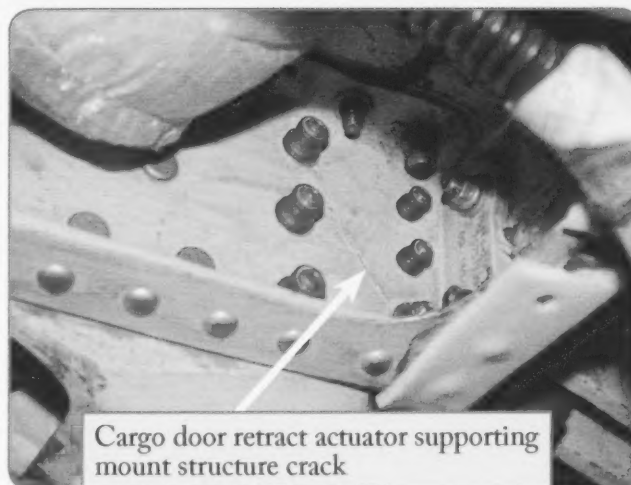
When the cargo door interior panel was opened, a crack was found emanating from the retract actuator frame mount attachment point.

*Through discussions with Aerospatiale Continuing Airworthiness engineering, it was determined that this condition does not impose a detrimental effect to flight safety and the repair is covered by the Structural Repair Manual (SRM) 52-31-00.*

Cargo door retract actuator supporting mount structure crack

The frame was repaired and the aeroplane was made serviceable.

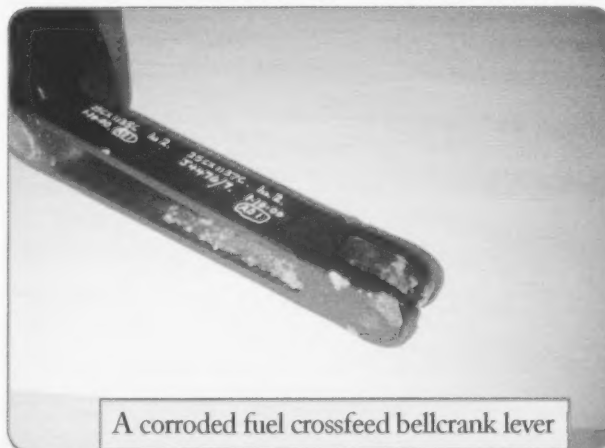
During a routine heavy maintenance 48 month inspection for corrosion, maintenance found the fuel crossfeed bellcrank lever severely pitted and corroded beyond acceptable repair limits.

A corroded fuel crossfeed bellcrank lever

The bellcrank lever was replaced with a new part in accordance with the Aircraft Maintenance Manual (AMM) 28-20-00.

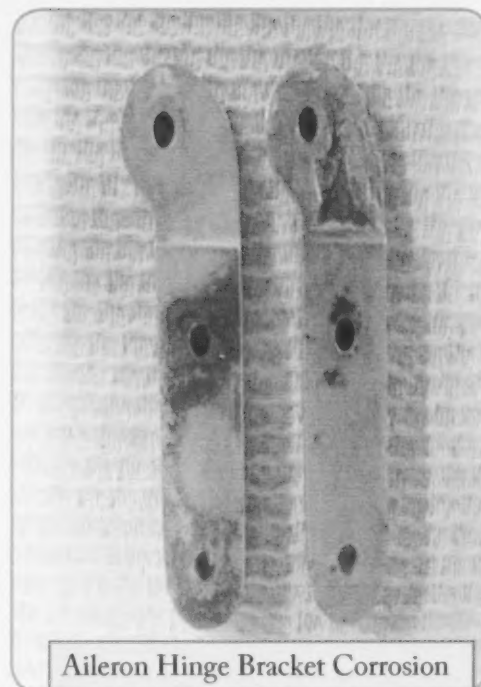
During removal of the right hand aileron for painting, the Aircraft Maintenance Engineer discovered severe corrosion on the inside hinge that reduced the bracket thickness to about 60%-70% of the original manufactured thickness. Corrosion was also found on the left-hand aileron hinge bracket.

Aileron Hinge Bracket Corrosion

Consequently, all 4 hinge brackets were replaced on the right-hand and left-hand ailerons.

*TCCA recommend that owners/operators comply with the FAA corrosion related recommendations contained within these SAIB(s):*

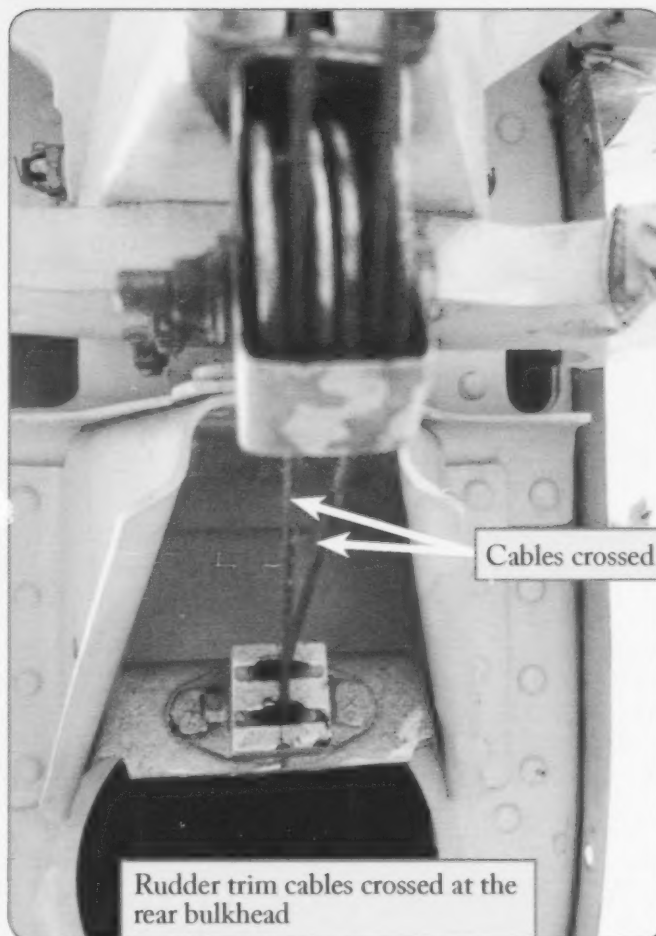
During cruise flight, the pilot attempted to centre the ball in the "Turn and Bank Indicator" by applying rudder trim, however the effect was opposite to normal (turned trim wheel left but the right rudder trim was noted to move). Soon afterwards, the pilot landed and maintenance personnel later confirmed that the rudder trim system was operating in reverse.

During these last 6 years, both flight crews and maintenance personnel had missed this potentially dangerous flight control error. Proper rudder control input would be critical during an engine failure in order to assist flying with asymmetrical thrust, especially in the fire suppression role/low altitude role that this particular aircraft is engaged in.

*These types of flight control errors would not have occurred if personnel following the maintenance instructions subsequently conducted dual independent inspections.*

*Alarming, these types of occurrences continue to occur on both the rudder and elevator trim systems and have resulted in fatal occurrences. It is strongly recommended that dual inspections be carried out as well as conducting visual checks on the actual flight tab position to ensure it corresponds correctly with the cockpit indicated positions. ✖*

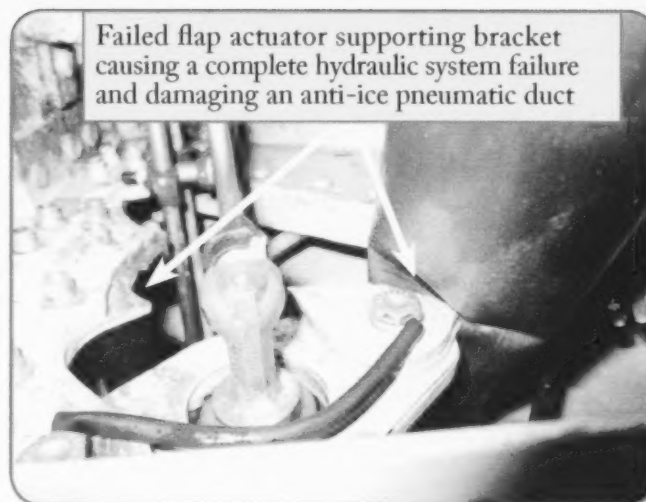
Upon selecting flaps down on approach, the crew noticed a hydraulic system low pressure light and corresponding loss of quantity. The crew declared an emergency and landed without incident. Maintenance discovered the #2 slat actuator had broken from its upper mount and moved aft, shearing a hydraulic line which caused the loss of the hydraulic system and damaging an anti-ice pneumatic duct.

*Upon review of the Web Service Difficulty Reporting System (WSDRS) database, additional occurrences were noted where Boeing Service Bulletin (SB) 727-57-0130 has been released to strengthen the slat actuator mount bracket. ✖*

Failed flap actuator supporting bracket causing a complete hydraulic system failure and damaging an anti-ice pneumatic duct

The flap actuator supporting mount was repaired, the hydraulic line and pneumatic duct replaced and the hydraulic system re-serviced, making the aeroplane serviceable.

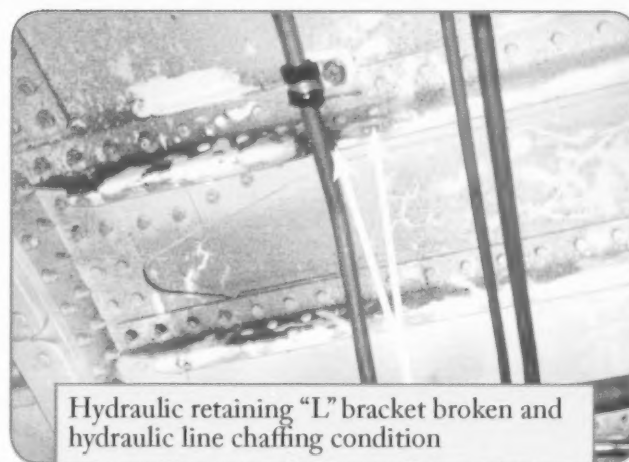
Maintenance investigation found a chaffed hydraulic line in the aft equipment bay that caused the loss of the hydraulic fluid. The line had chaffed against stringer #7 due to a broken retaining "L" bracket.

Hydraulic retaining "L" bracket broken and hydraulic line chaffing condition

The hydraulic line and "L" bracket were replaced and the damage to the stringer was repaired making the aeroplane serviceable.

*When performing service checks and walkarounds, it's important to inspect for the serviceable condition of hydraulic line retaining brackets and clamps. ✖*

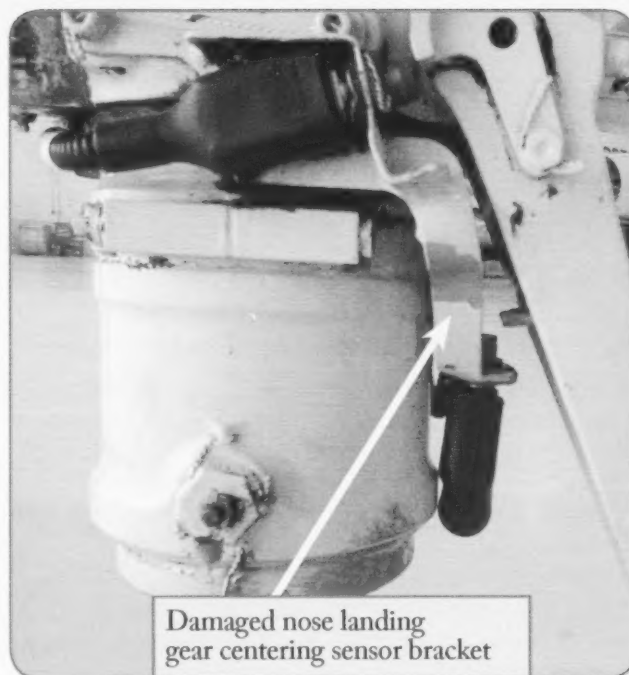
*As stated by the operator, Bombardier Advisory Wire 600T-2171 has been issued identifying the possible scenario where damage to the NLG when using a towbarless tug can occur.*

Damaged nose landing gear centering sensor bracket

The NLG centering sensor bracket was replaced and the aeroplane was returned to service.

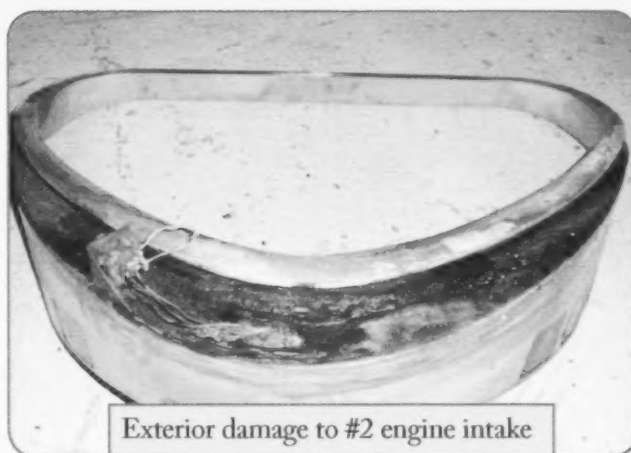
An investigation by line maintenance personnel revealed that the engine intake adaptor heater was severely damaged from a significant overheat event during operation. Soot evidence in the engine area indicates possible flames were generated; however the crew received no cockpit fire indication advisories. Evidence of soot damage was also found in the area of the electrical connector area for the heater.

*A review of the Service Difficulty Report (SDR) database has revealed previous failure events where the crew smelt a burning odor entering the aeroplane. In particular, one significant ground event (2004) reported smoke and flames coming from the engine cowling and air intake section caused by a failed intake adaptor heater (pre-mod part number (P/N) 4100S028-01).*

*Investigation by the manufacturer (Zodiac Aerospace) of the engine inlet adaptor heater revealed that during manufacturing process, the heating element is difficult to place with the casting and as a result it can cause overheating during the manufacturing process or in the field. In the interim, it is recommended that maintainers routinely inspect for any visible damage to the engine inlet area and associated electrical connectors. ✖*

The failed intake adaptor heater was quarantined and has been sent to the manufacturer for further analysis.

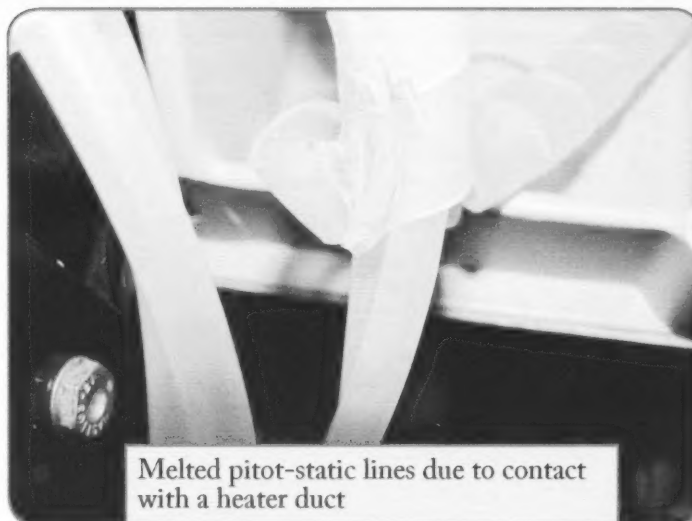
The flight crew reported to maintenance that the captain's airspeed indicator was reading up to 40 knots lower than the co-pilot's airspeed in flight. Maintenance performed a pitot static leak check and visual inspection of the aeroplane revealing that both the captain's pitot and static plastic lines were melted from contacting a cockpit under-floor heater duct.

The pitot and static plastic lines were routed adjacent to a heater duct, causing the contact and eventual melting of the pitot-static lines.

Melted pitot-static lines due to contact with a heater duct

The affected pitot-static lines were replaced and precaution was taken to relocate the replacement lines at a suitable distance away from the heater ducts, making the aeroplane serviceable.

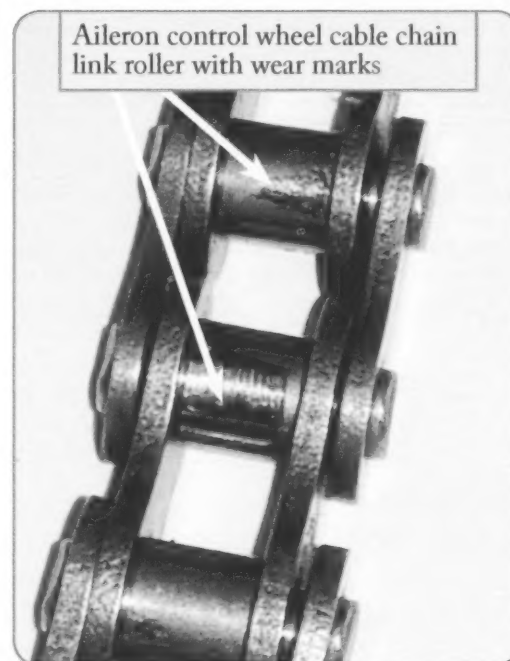
Further investigation found that the chain was binding at the control wheel sprocket area within the control column. The chain looked dry (no lube), its link rollers worn and showed evidence of wear at the link joints. There was also evidence of the chain contacting the insides of the control columns housing (slight loss of metal and primer).

Aileron control wheel cable chain link roller with wear marks

*understood that the aileron control wheel jam was caused by a combination of a lack of lubrication and excessive wear on the chain link rollers. With the excessive wear of the chain and a control wheel roll input applied, the chain would have a tendency to ride up the control wheel sprocket teeth and bind through contact with the inside wall of the control column housing.*

*Also noted by the operator was an error in the AMM which omitted to include the specific lubrication of the aileron control wheel chain.*

The chain was replaced and lubed, making the aeroplane serviceable.

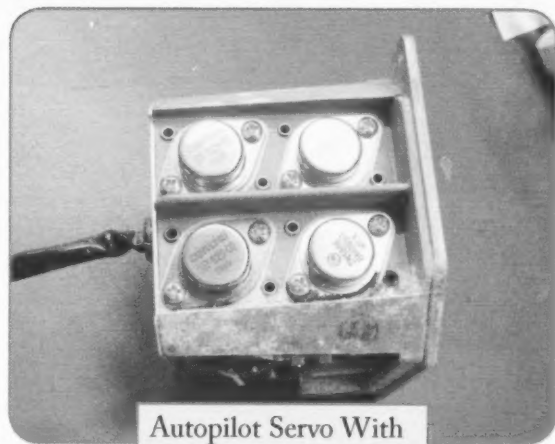
The subject aeroplane was brought to an avionics repair shop with an autopilot snag. It was determined that the pitch servo had sustained water damage that resulted in corrosion and an intermittent short on the clutch engage wire. This in turn caused the failure of a transistor. To rectify the problem, the autopilot computer was repaired and the pitch servo was replaced. The aeroplane is equipped with amphibious floats and has drainage holes in the bottom fuselage.

*Corrosion in float aeroplanes is an ongoing concern. Avionics components are also subject to corrosion internally and must be considered when conducting inspections. ✖*

Autopilot Servo With Corroded Transistor

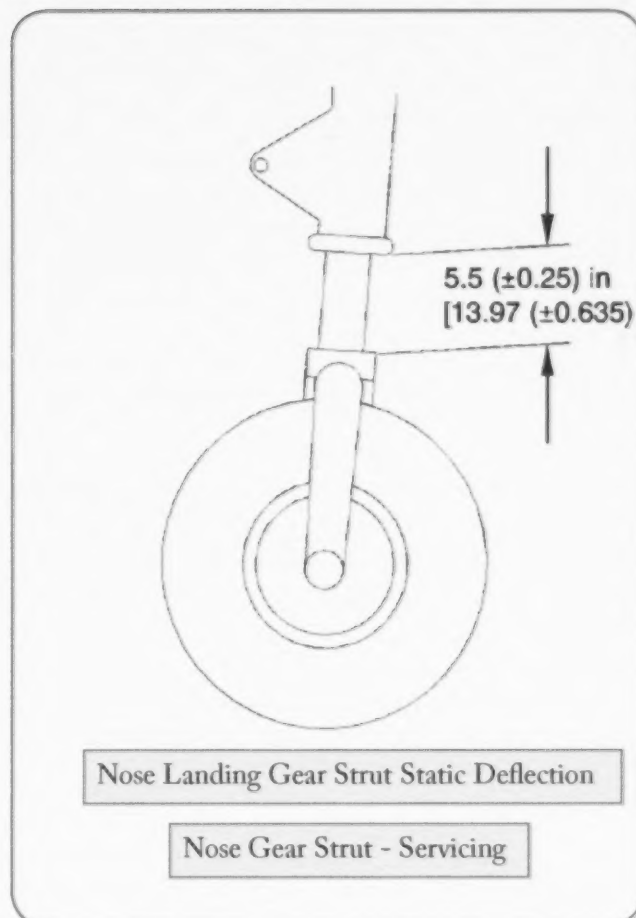
Maintenance inspection found the nose landing gear (NLG) oleo was flat which prevented the internal NLG strut centering cam mechanism from aligning the NLG wheel prior to touch-down.

The NLG showed no indication of hydraulic fluid leakage where it was confirmed that the nitrogen gas charge was underserviced, causing the NLG wheel misalignment.

*The attached figure represents the required oleo extension when referencing the "Alternate method" AMM servicing procedure.*

*Recently, Learjet issued Service Bulletin SB 60-11-4 which provides the installation of a service instructions name plate on the NLG strut that defines the AMM "Preferred Method" servicing procedures. ✖*

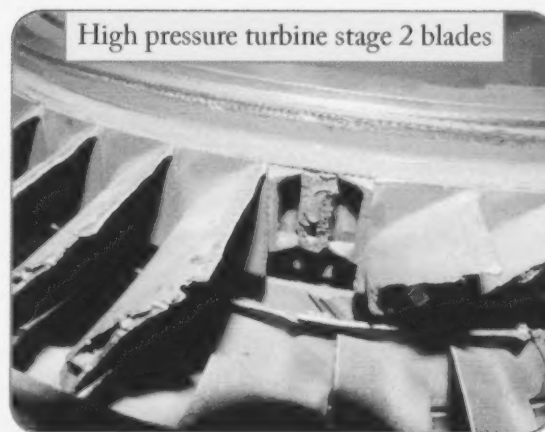
While climbing through 8000 feet, flight crew heard a loud noise followed by a yaw to the right. Right engine parameters indicated the engine was spooling down. Flight crew secured the engine, declared an emergency, turned back and landed without further incident. Initial inspection of the engine by local maintenance revealed no damage to the fan blades however there was significant damage to the turbines.

*Engine teardown revealed the failure was caused by high pressure turbine blade release. This is a known problem for CF34 engines and is caused by corrosion under the blade platform. Service Bulletins 72-0228 and 72-0242 introduce re-designed blades that address this issue. ✖*

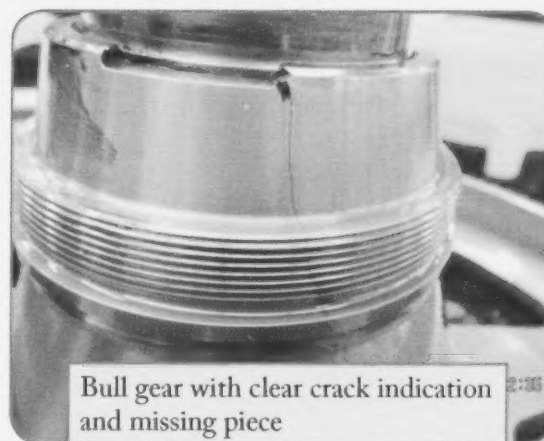
SDR # 20130826001

At disassembly of the reduction gear box module (for a light overhaul due to metal in oil), three cracks were noted in the 2nd stage spur gear shaft wall. The cracks were originating from the n° 15 bearing mating face and propagating forward. The cracks were adjacent to each other approximately 1.52 mm (0.060") apart. There was material breakout at the tooling slot corner. The separated piece of material was picked by the magnetic chip detector in-field. The missing piece is approximately 1.52 mm (0.060") wide, 2.54 mm (0.100") long and 1.27 mm (0.050") deep.

*Metal found in oil systems and chip detector indication is an indicator of engine wear or distress. This can be a precursor to catastrophic failure. These conditions must be investigated further to determine the source. Manufacturer's instructions regarding metal in oil found in maintenance manuals, Service Bulletins (SB's) and Service Information Letters (SIL's) should always be followed. ✖*

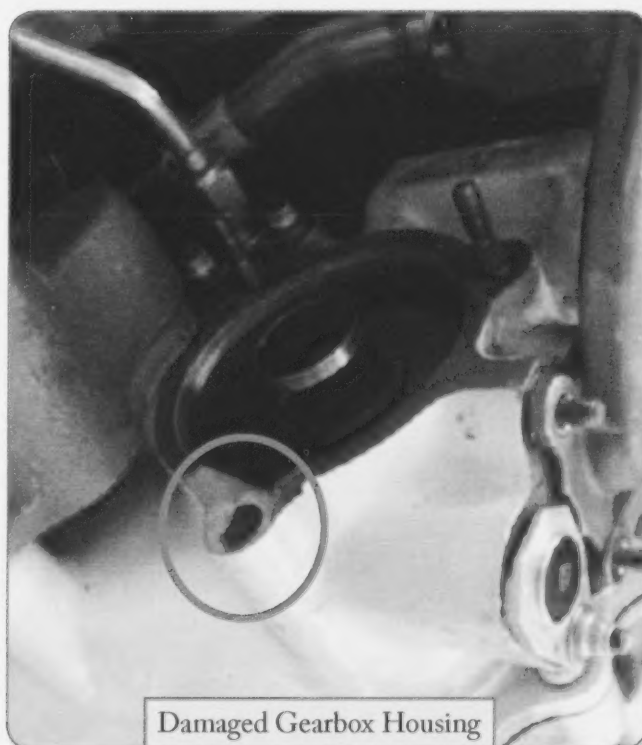
During a visual inspection of the engine gearbox, it was noted that the oil filter housing assembly lower mounting stud ear was cracked. The corrective action taken was to replace the aft gearbox housing case.

*Transport Canada Civil Aviation would like to raise awareness of this defect to operators of TFE731 engines. Due to the location of the stud (six o'clock position) and the length of the housing, the possibility of accidental damage is high. The cause in this case is not known; however it could have been the result of corrosion (or casting inclusion), a past over torque or perhaps an accidental overload or impact damage during installation or shipping. Whatever the case, maintainers are urged to be cautious when working on complex systems and always follow manufacturers instruction. ✂*

Damaged Gearbox Housing

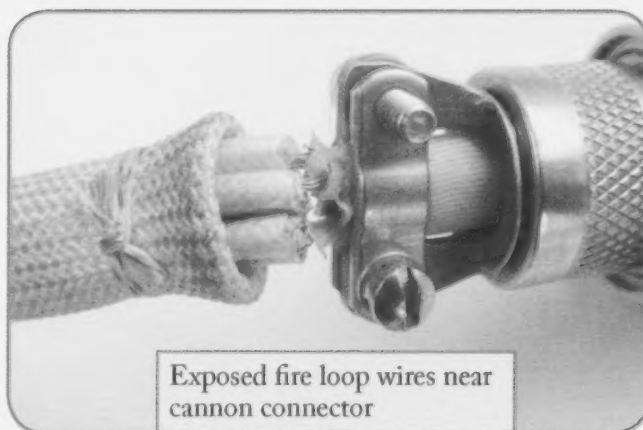
During routine maintenance, the left hand jet pipe loop "A" was found unserviceable. Troubleshooting found that the engine fire detection wiring harness was broken at the pylon connector. The fire detection and fire protection wiring harnesses were replaced. This defect, if unnoticed, might have resulted in an in-flight engine shutdown due to a false engine fire or jet pipe overheat warning.

*This was a good find by the maintenance team who were doing the inspection (in particular considering the defect's location in the pylon). As aeroplane fleets in Canada and abroad age, there will likely be more of these issues discovered. ✂*

Exposed fire loop wires near cannon connector

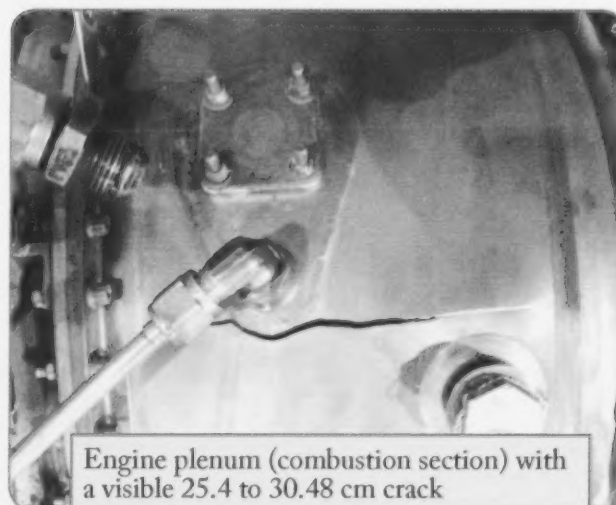
A detailed visual inspection confirmed a large 25.4 to 30.48 cm (10 to 12 inch) long crack in the combustion liner. The engine was removed and replaced.

*The plenums on these engines are operated 'on condition'. The type certificate holder (Honeywell) has issued Service Bulletin 72-2178 (Combustion Section—inspect combustion case assembly) that recommends it be accomplished at each scheduled fuel nozzle inspection and/or replacement. Transport Canada Civil Aviation recommends that operators familiarize themselves and comply with this service bulletin. ✖*

Engine plenum (combustion section) with a visible 25.4 to 30.48 cm crack

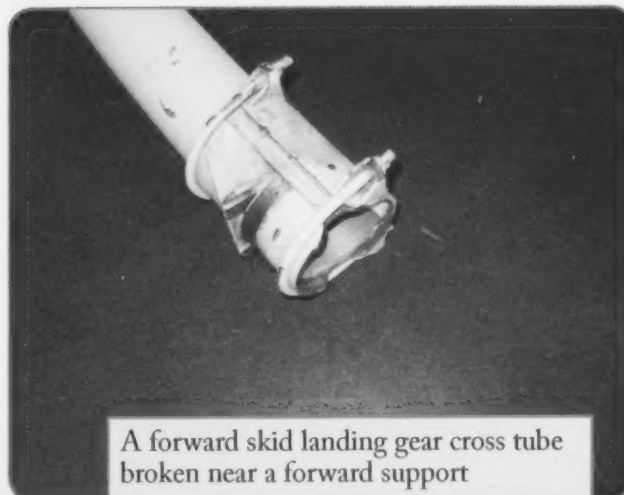
The pilot landed at a forest service lookout tower and heard a bang. He thought he had hit a rock. On landing at a local airstrip, the helicopter sat in an unusual attitude. The forward skid landing gear cross tube was found broken near a forward support.

*This cross tube is the subject of recurring Bell Helicopter Alert Service Bulletin (ASB) 212-09-132. The ASB requires a detailed inspection every 7 days. The Federal Aviation Administration (FAA) and the manufacturer have been informed and an investigation is ongoing to determine if the ASB inspection interval requirements are sufficient. ✖*

A forward skid landing gear cross tube broken near a forward support

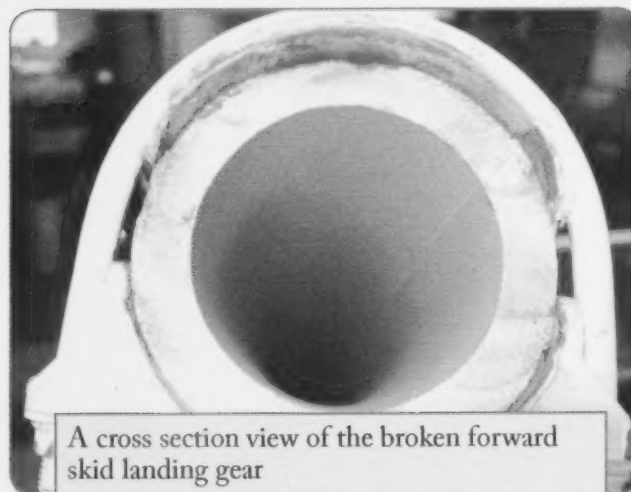
A cross section view of the broken forward skid landing gear

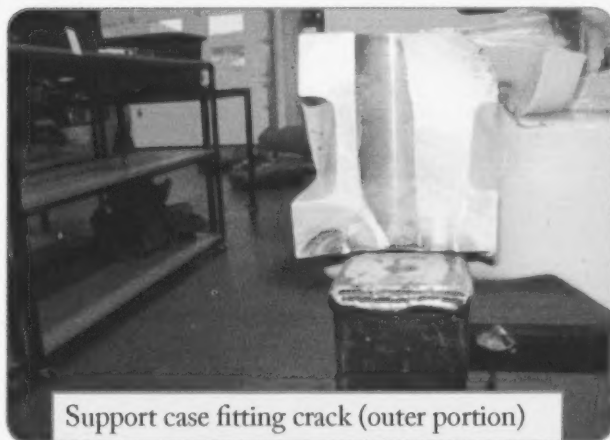
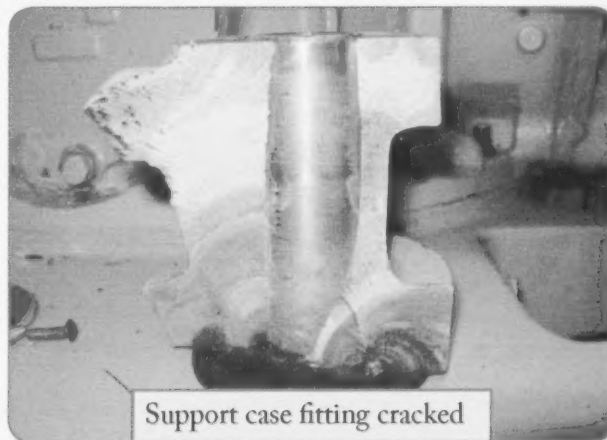
During a routine daily aircraft inspection, an Aircraft Maintenance Engineer (AME) was inspecting the main transmission and noticed the support case was cracked on the left hand side by the airframe attachment bolt. The transmission was removed and it was found that the support case leg was broken with the crack originating from one of the small bushing attachment screws.

*The Original Equipment Manufacturer (OEM) is currently investigating this issue. In the interim, Transport Canada Civil Aviation recommends maintenance personnel to remain vigilant while inspecting this area of the transmission. ✖*

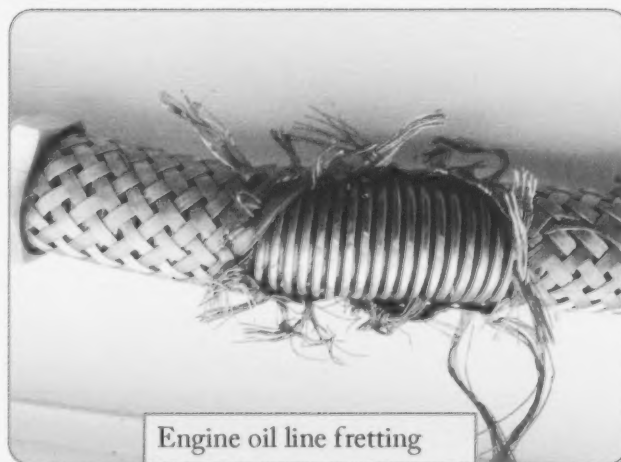
The engine was removed from the aircraft due to a service inspection required for Bell helicopter Alert Service Bulletin (ASB) 407-13-99RA. During that time it was found that oil line part number (P/N) 70-037A0910-000 was seeping black oxide out of its internal portion. After further inspection, the steel braids were found cut.

*Transport Canada Civil Aviation reminds maintainers of the importance of keeping adequate clearance on all hydraulic, fuel and electrical lines to prevent fretting. This defect was discovered before a potential catastrophic occurrence could have occurred. ✖*

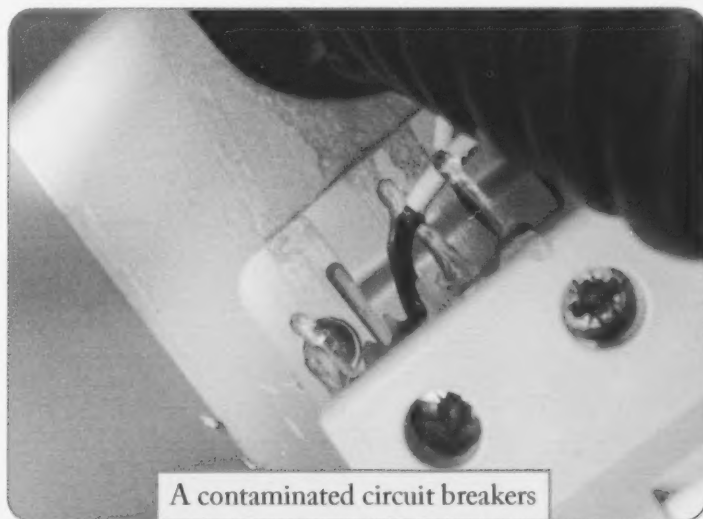
It was found that the soap dispenser had been leaking on to the circuit breaker of the forward lavatory power outlets. The circuit breaker has open terminals on the top allowing the liquid soap to make contact and create a short. Troubleshooting showed that the soap dispenser bottle had not been properly tightened and that the circuit breaker had no protection against leaks. The circuit breaker is located directly below the bottle.

A contaminated circuit breakers

The circuit breaker required replacement due to contamination and possible internal damage/short and the soap dispenser bottle was properly installed.
